FLIGHT DESIGN USA SAFETY DIRECTIVE No.15

Revision 1

Trim Tab Reinforcement

- Pages: 3 (Three)
- Date Issue: June 29, 2007
- Scope: CTSW 2006-2007, serial No. 06-07-15 to serial No. 07-05-18

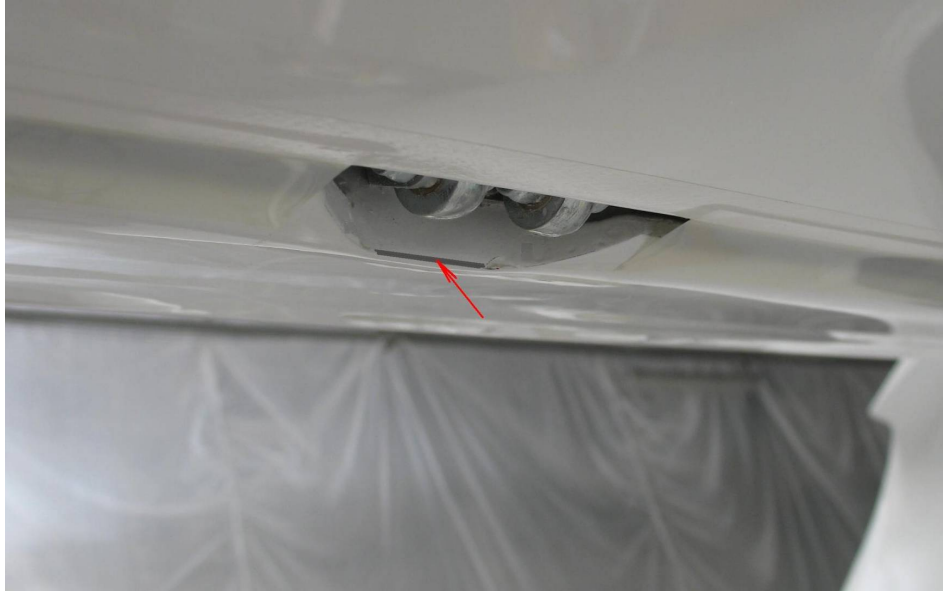
Recently a CTSW 2007 exhibited significant stick vibration in pitch during high speed flight. The aircraft remained controllable, and, after slowing down, the vibration stopped. The investigation ruled out the balancing of the trim tab as these are mass balanced at the factory in accordance with detailed flutter and ground vibration tests and analysis. The investigation did determine that a pitch control vibration could result from the debonding in the area of the Trim Tab Bracket (Part No. KA 3011110) from the trim tab (anti-servo tab) as evidenced by a crack located at the attachment point. (Fig. A)

Fig. A: Inspection area: Trim tab control horn attachment point
(Seen from underneath the stabilator)

Flight Design is mandating an immediate inspection of the Trim Tab Bracket attachment area, with special consideration to the composite structure of the trim tab. The inspection will be performed before the next flight, and thereafter, prior to the first flight of the day. When inspecting the trim tab, the surface should be submitted to a gentle load by hand in order to expose any potential damage.

If cracks are found in the area of bonding (attach point) (Fig. A), the aircraft must not be flown until the mandated reinforcement procedure has been completed.

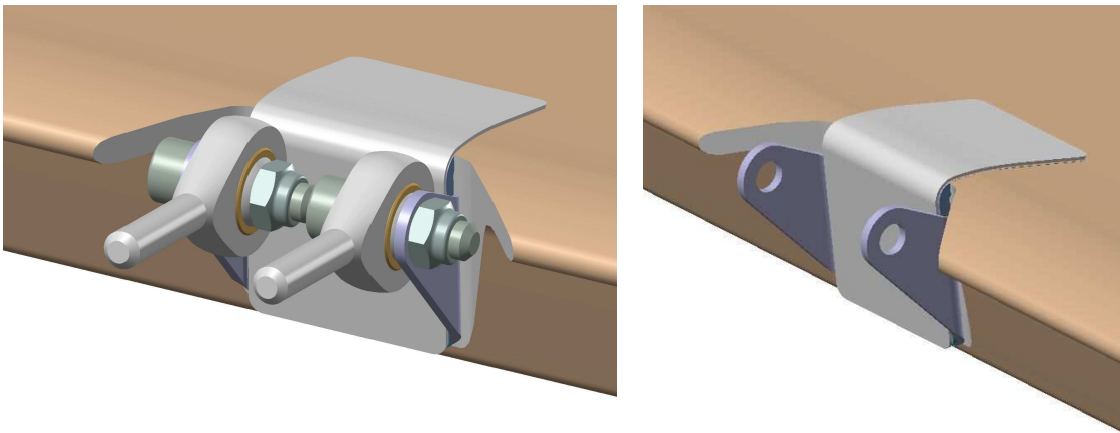
Fig B1 & B2: Reinforcement installed to the trim tab
(Tab shown bottom surface facing up)

The reinforcement procedure consists of reinforcing the point at which the control horn is bonded to the trim tab by the addition of specifically designed part manufactured by Flight Design (WA 3011011). The part is glued (bonded) to the control rod bracket and the lower trim tab surface with resin and delivers a secondary load path for the trim tab control forces.

The modification can be done without removing the trim tab, and does not require painting. (Figs.B1 & B2)
