FLIGHT DESIGN USA SAFETY DIRECTIVE No.8

Engine Mount Bolts

SAFETY ALERT

- Pages: Two (2)
- Supersedes: Technical Advice No.8, Dated June 1st, 2005
- Re-issue to conform to ASTM format
- Date Issued: January 1, 2006
- Date Effective: January 1, 2006
- Scope: CT, CT2K, and CTSW in all versions up to and including serial No. 05-05-01

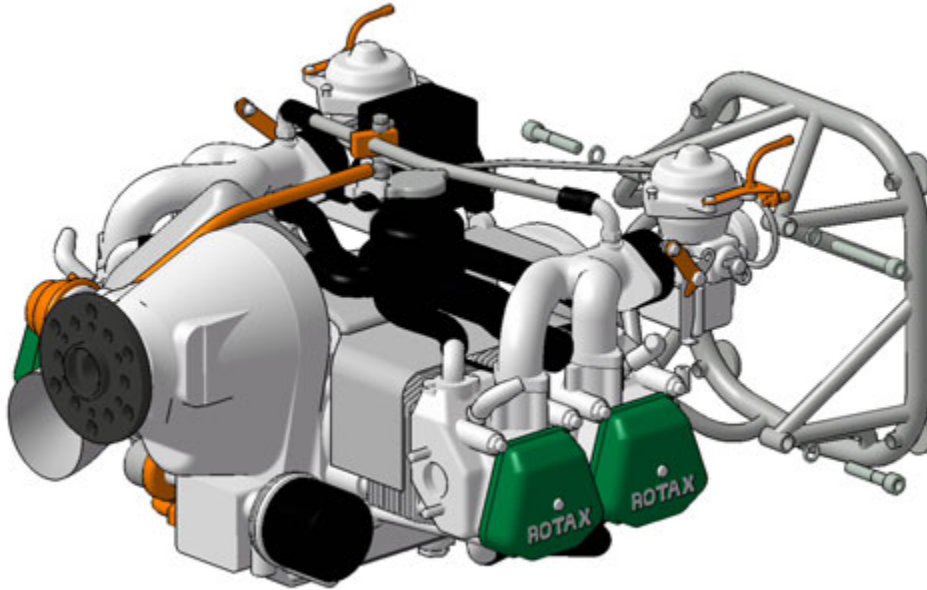
Three aircraft were found to have partially loosened engine mount bolts that connect the Small Engine Frame to the engine.

Change the torque moment of the bolts (part No. C9996511 & C9996098F), which connect the Small Engine Frame to the engine. The original torque moment was 30 Nm. (22ft.lbs). The new Rotax recommended values are a minimum of 35 Nm. (25.8ft.lbs), not to exceed 40 Nm. (29.5ft.lbs).
