FLIGHT DESIGN USA SAFETY DIRECTIVE No.9

Radiator Isolator Mounts

SERVICE BULLETIN

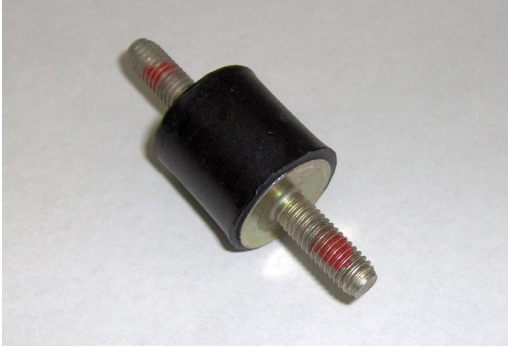
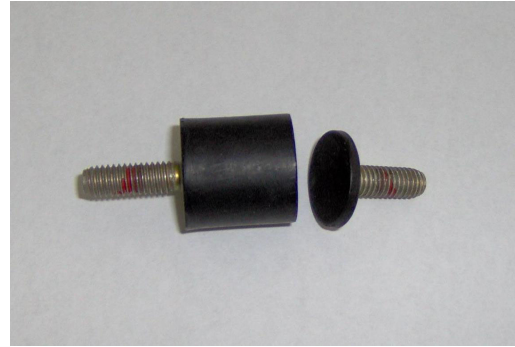
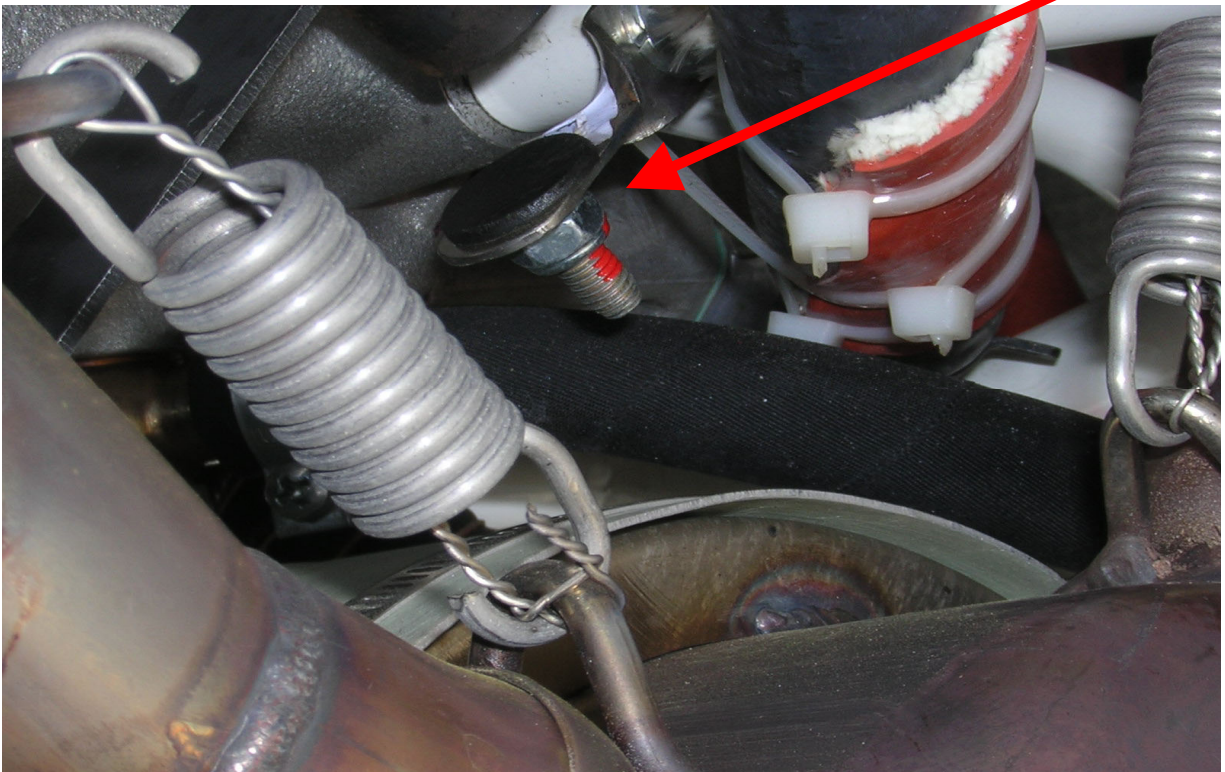
During a routine inspection of a CT, it was found that the rubber radiator isolator mounts had separated into two parts. Upon examination, three other aircraft were found to have damaged isolators.

Before the next flight, remove the upper and lower cowling. Carefully inspect all radiator isolator mounts by hand. If any are found to be damaged, please contact Flight Design USA to obtain a replacement.

Inspect the radiator isolators at each scheduled inspection interval.
