<b>SERVICE BULLETIN</b>	
	<b>Flight Design GmbH</b> Sielminger Str. 51 D-70771 L.-Echterdingen Tel +49 (0)7021 / 80460-0 Fax +49 (0)7021 / 80460-69 E-Mail: <a href="mailto:airworthiness@flightdesign.com">airworthiness@flightdesign.com</a>	<b>SB-ASTM-CTLS-02</b> <b>Revision 00</b>
	Date of Initial Publication: <b>30-Nov-2009</b> Publication Date of this Revision: <b>30-Nov-2009</b>

## Rudder Centering Fork - Control Stop Replacement

### SB-ASTM-CTLS-02

Model: CTLS

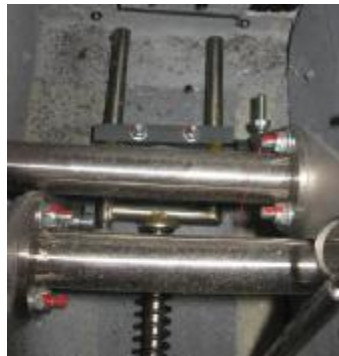
This is the rudder stop system that was installed to the CTLS affected by this SB ex factory. In this system the stop is provided to the rear end of the rudder centering fork, installed to the tunnel, below the instrument board. See following Fig. 1 and Fig. 2 for illustration.

This system is the system affected by this SB.

The old fork stop system, that guides the rear end of the rudder centering fork, must be uninstalled when the rudder stop plates are installed. To do this, remove the three bushings, bolts and thrust plate shown in Fig. 14 from the fork mount block. Unscrew three (3) DIN 912 M6 bolts (Fig. 14). Discard these parts.

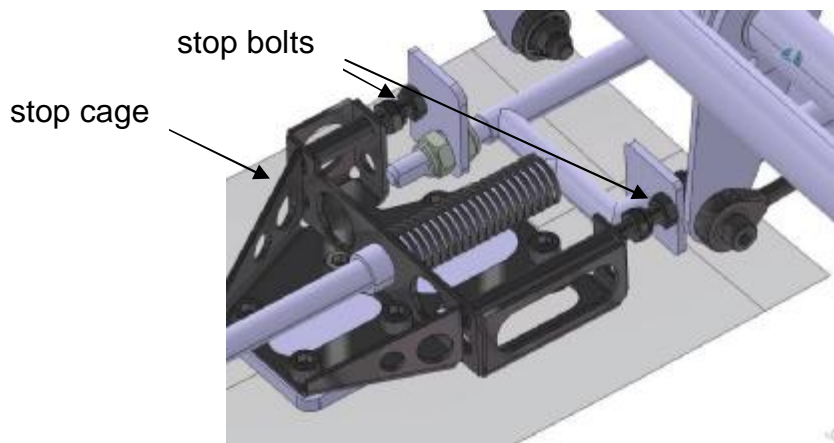
The new fork stop system provides a stop not to the rear end of the rudder centering fork, but to the thrust plates where the rudder centering fork contacts the bolt heads from the rudder pedal levers. The variant is clearly recognizable by the steel welded cage that provides the stops by means of adjustable bolts. See following Fig. 3 for illustration.

This stop device represents the valid type design and is used in serial production at the time of issuing of this SB. Only on aircrafts where the Rudder Stop Plates as by 3.1.3 cannot be used, this new fork stop system must be installed following SB [2].

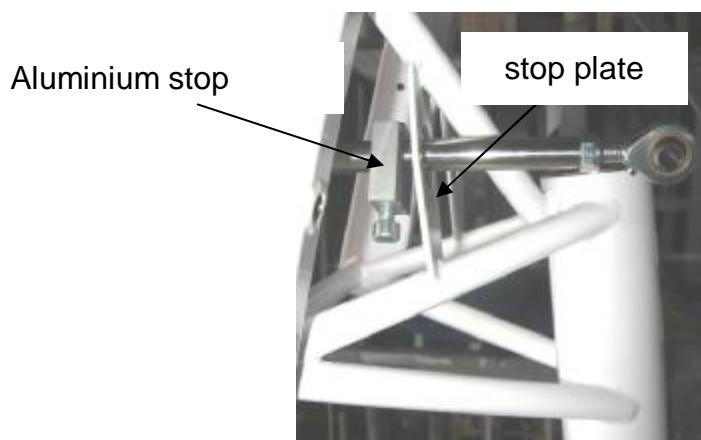
The rudder stop plates provide rudder stop not at the rudder centering fork. Aluminium stops, positioned to the control rods that connect the pedals with the nose gear steering, come to a stop against two stop plates welded to the big engine mount, in front of the firewall. See following Fig. 4 for illustration (only partially installed situation).

This stop device represents the valid type design previous to the introduction of the old fork stop system. It has been replaced in production due to the more complex adjustment principle, coupling with the rudder control rope pretension. On aircrafts where the welded stop plates are still available, this previous stop system shall be used again as it is easier and faster to be installed. The modification procedure is provided by this SB.

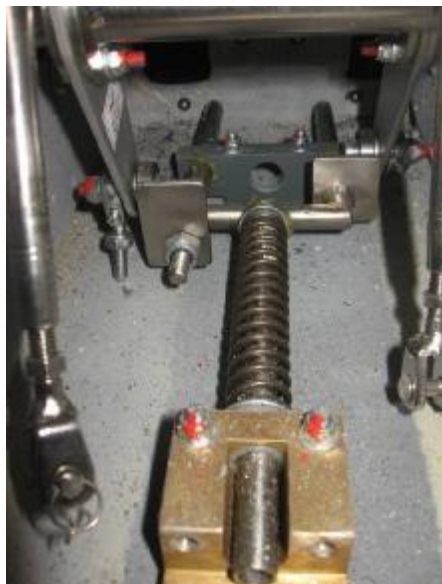
Fig. 5

1. The rudder centering fork is not deformed, fork tubes are straight, and fork plates (small square plates shown on the fork, Fig. 5) are not bent or deformed. The correct configuration is shown on Fig. 5, 6;

When deformation is detected at the rudder centering fork, this fork must be exchanged.

Make certain the position of the left side fork plate (Fig. 5 and Fig. 15, above, left side) is adjusted to the same position as on the original fork.

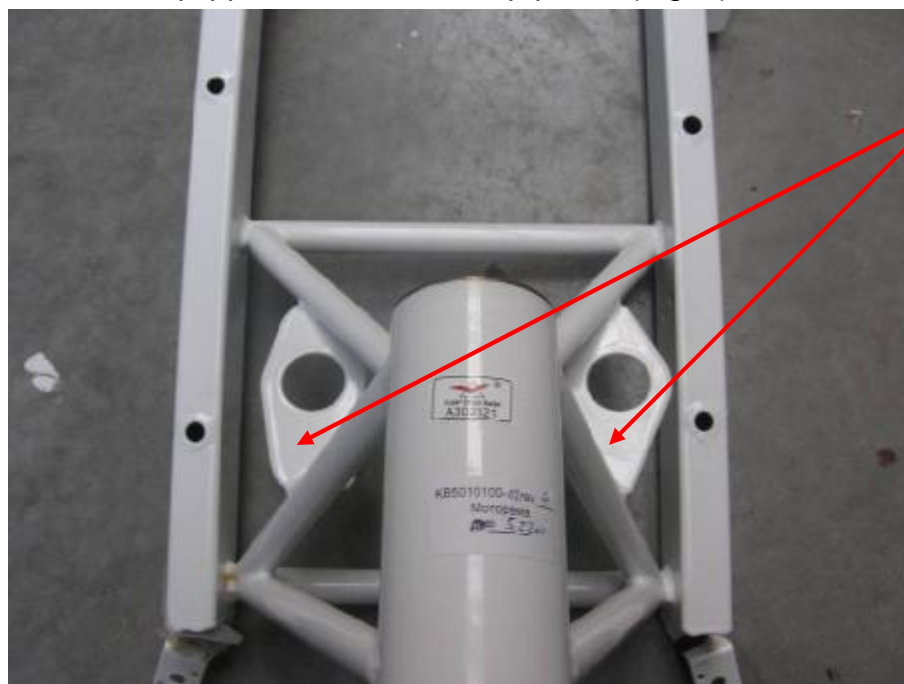
Fig.7

The engine mount is equipped with welded stop plates (Fig. 7);

When the welded stop plates are available, the stop system shall be changed towards the Rudder Stop Plates variant.
