SERVICE BULLETIN	
	Flight Design GmbH Sielminger Str. 51 D-70771 L.-Echterdingen Tel +49 (0)711 90287-0 Fax +49 (0)711 90287-99 E-Mail: airworthiness@flightdesign.com	SB-ASTM-CTSW-07 Revision 00
	Date of Initial Publication: 30-Nov-2009 Publication Date of this Revision: 30-Nov-2009

Stabilizer Rear Wall Stiffening SB-ASTM-CTSW-07

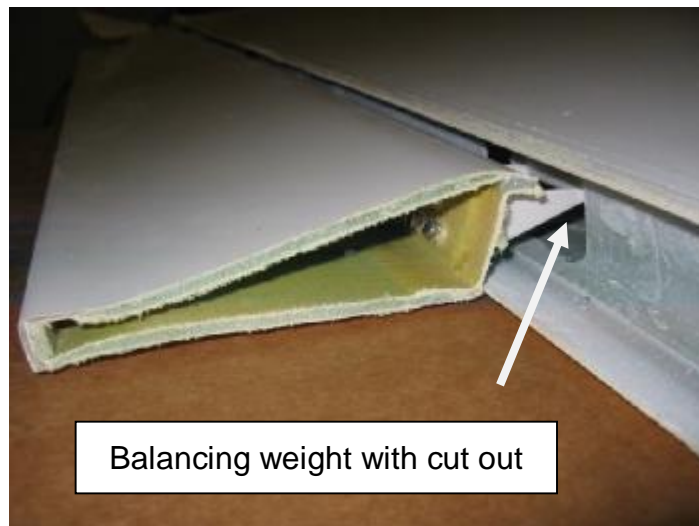
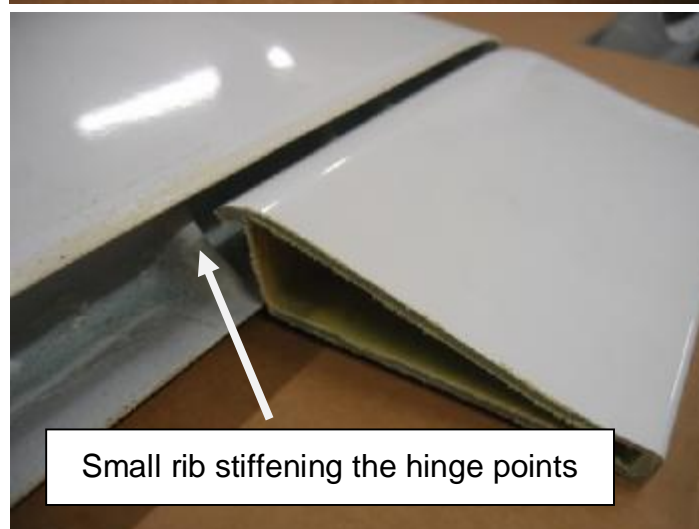
4.2 Pictures

Increasing play in the trim tab control system can lead to vibrations in the trim tab in flight at high speeds. This vibration can be clearly felt by the pilot when exceeding a certain speed and stops again when slowing down.

Pictures in the Appendix of this SB illustrate balancing weights with cut outs and the small ribs, which supports each hinge point.

Stiffening of the rear wall of the stabilizer by installation of ribs in the cut-outs for the balancing weights, and direct support of the individual hinge points with small ribs.
