FLIGHT DESIGN

Supplement to the Maintenance Manual Tow Bar Interface and Maintenance

Airplane Type : CT / MC

Document Number : AZ 0480 0001_00

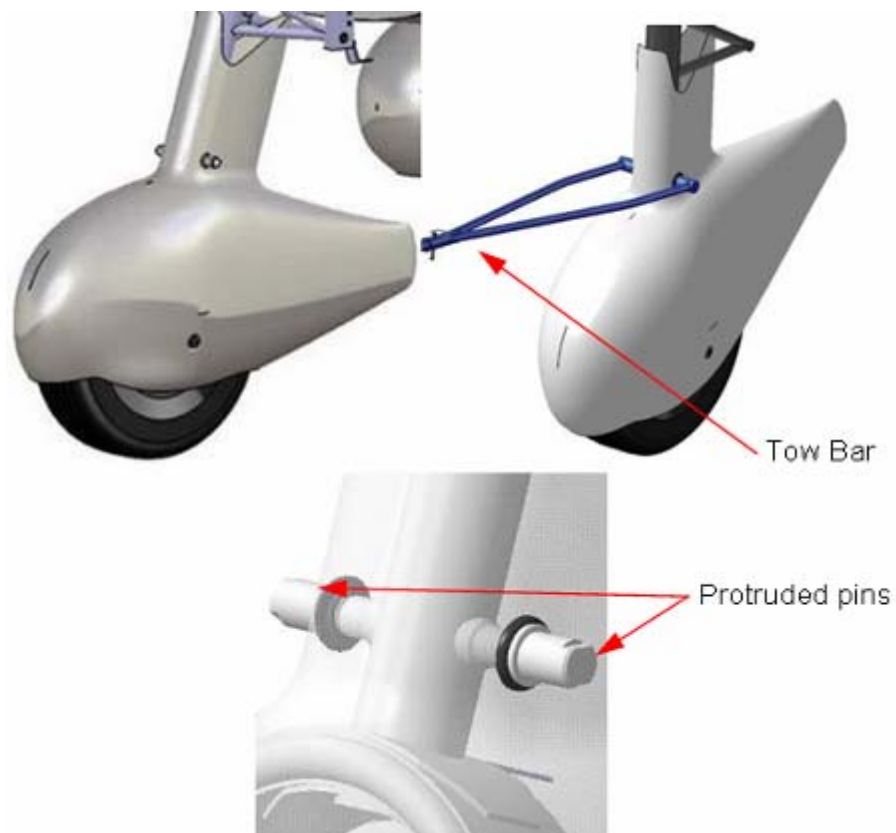
Fig. 1

When the aircraft is equipped with an interface for Tow Bar connection, there are two protruded pins attached to the nose gear leg. The tow bar is attached to these pins. The tow bar attachment size fits to one of the most common tow bars, that also fit most Cessna aircraft models. See figure 1.

Before being able to remove the nose wheel fairing, the tow bar pins (Fig 1, bottom) must be removed using a suitable flat spanner. When the pins are removed, the nose wheel fairing can be removed following the standard procedure.

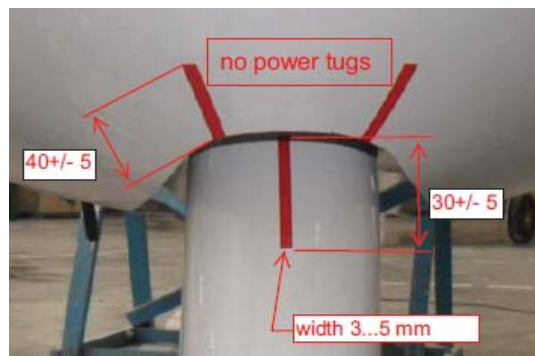
For this prepare three pieces of red film, in accordance with Fig 2.

Use ORACAL 951 Series red film, or 3M red film or another red film with similar adhesive properties and color fastness.

Install the “No Power Tugs” sticker as shown on Fig. 2.

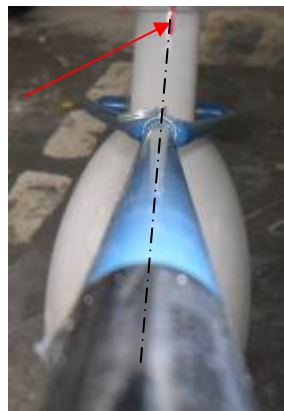
Fig 3.

Mark the center of the nose landing gear fairing. This marking must align with the tow bar (Fig 3).

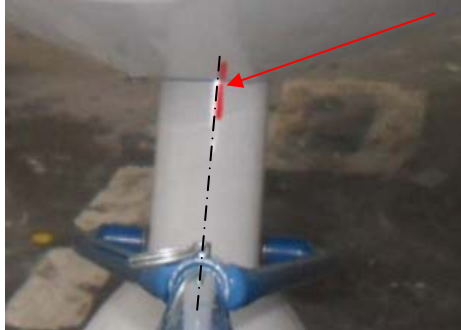
Fig 4.

Carefully turn the nose landing gear to the left, up to the stop. Mark this position on the cowling with the tape. This marking must align with the center mark on the nose wheel fairing (Fig 4).

Check the correctness of the markings: carefully turn the nose landing gear, looking along the tow bar and using the center marking on the nose wheel fairing. If the markings on the fairing and on the cowling align and the nose landing gear reaches the stops, then the markings are done correctly. The stops shall never be reached before the markings line up. It is acceptable when the markings line up just before the stop is reached.

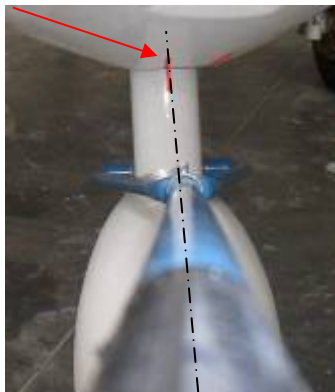
Fig 5.

Do this for the right side (Fig 5).
