BRS Activation Handle Inspection & Rework

This document is used to provide additional support to the BRS SB 07-05

- Pages: Two (2)
- Date Issued: August 29th, 2007
- Scope: all CT up to S/N 07-03-07 (excluded) with BRS parachute system. Details below under Affected Aircraft.

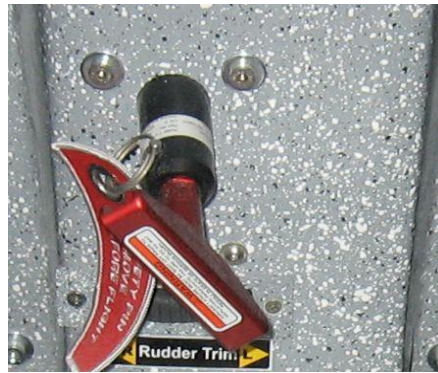
- BRS parachute system
- Parachute system activation handle mounted to the cabin bulkhead as shown below, above the rudder trim wheel.
- Parachute system handle installations of the fixed, non pivot-type (as shown below Fig 1).

Fig. 1: BRS parachute system handle installation which **is affected** by this SD

As it can not be deduced where and under what conditions this handle was improperly assembled, BRS and Flight Design are mandating an inspection and rework if required of all BRS parachute system handles of this type and installation.

BRS and Flight Design are mandating an immediate inspection of the handle according to the BRS Service Bulletin SB 07-05 issued 8-24-07.

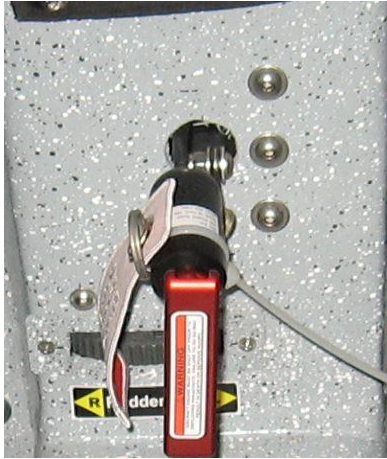
- with different parachute systems than BRS (not applicable in USA)
- with BRS rescue systems that have the new installation (planes from 07-03-07 onwards have an attachment of the handle with a swivelling “pivot” in the installation.)

Fig. 2: New BRS rescue system handle installation which is **not affected** by this SD
